Marine Scotland Science Report 05/12

Movements of Returning Atlantic Salmon Through  
Tongland Fish Pass

# Movements of Returning Atlantic Salmon through Tongland Fish Pass

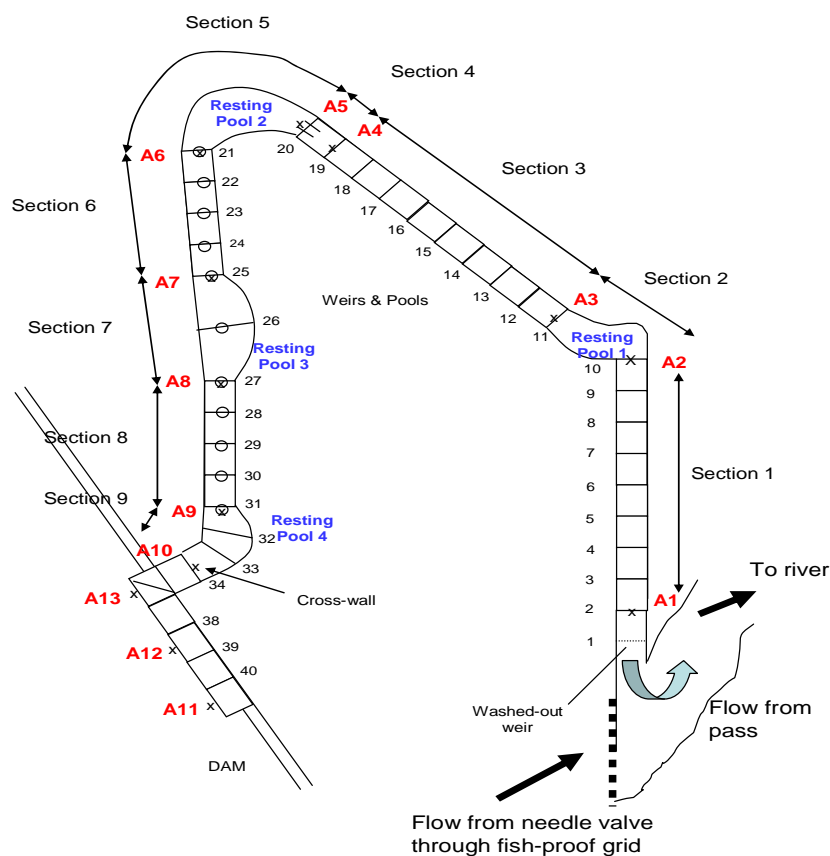
Figure 1: Map of the Tongland fish pass showing the arrangement of pools and locations of PIT detectors (A1-A13). The upper four pools are also fitted with diagonal wooden cross-walls (not shown).

The fish pass comprises a series of 39 chambers (Fig. 1), which were originally connected by submerged orifices. The upper five chambers each contain diagonal wooden cross walls (Fig. 1 shown only in chamber A13 for clarity, Plate 1f). There are four enlarged chambers, termed resting pools, presumably in anticipation that salmon might need such structures to recover during ascent of the ladder (Plate 1d). The other chambers on the main ascent are smaller and more turbulent than the resting pools. Flow through the pass was originally controlled by sluice gates that could vary the area of each orifice. However, the pass was subsequently modified such that on Sections 1, 3 and 4 (Fig. 1) each of the gates was closed and notches were cut into the walls between chambers, thus converting them to pool and over-fall structures (Plate 1a, 1e). On Sections 6 and 8, salmon must now jump through the original orifices, which are located above the water level (Plate 1b). Within Section 7, salmon must pass through a submerged orifice and Vaki fish counter tunnel located within a weir in the middle of Resting Pool 3 (Plate 1d). Fish may exit the pass via three gates (A11, A12 and A13, Fig. 1, Plate 1f) which each activate at different loch levels and so maintain the potential for operation of the pass under a range of electricity generating conditions.

The fish pass was fitted with a series of detectors (Wyre Micro Design Ltd) that recorded passage of any fish tagged with a PIT tag. Detectors were placed at interfaces of sections of the pass that differed markedly in character (Fig. 1). Detector A5 was at the top of a fish counter flume that was active in 2007 but removed prior to observations in 2008. The detectors were connected to a computer that logged the date, time and tag number of each passing fish. Each of the three exits from the pass was fitted with a specially designed detector to maximise range in these regions of extensive metal work, which reduces detection range. Despite this custom engineering, it was acknowledged that there was a degree of uncertainty as to the efficiency of detection, which could not easily be quantified. In total, 10 salmon caught in the box trap were tagged in July and August 2007, 4 in November 2007 and 15 in July 2008. A further group of 15 salmon was captured within the pass in 2007 by electro-fishing (Table 1). This group was displaced downstream and released into the main river channel c. 50 m below the fish pass entrance.

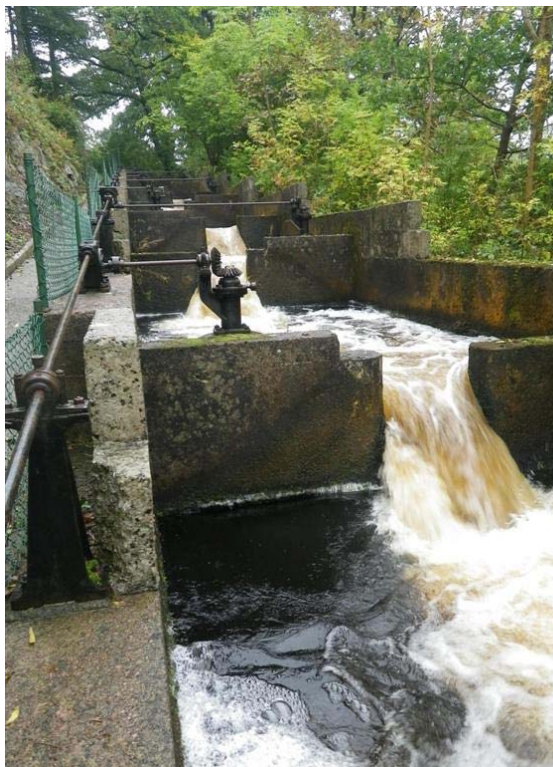
Plate1a: Pool and over-fall structures of Sections 1, 3 and 4.

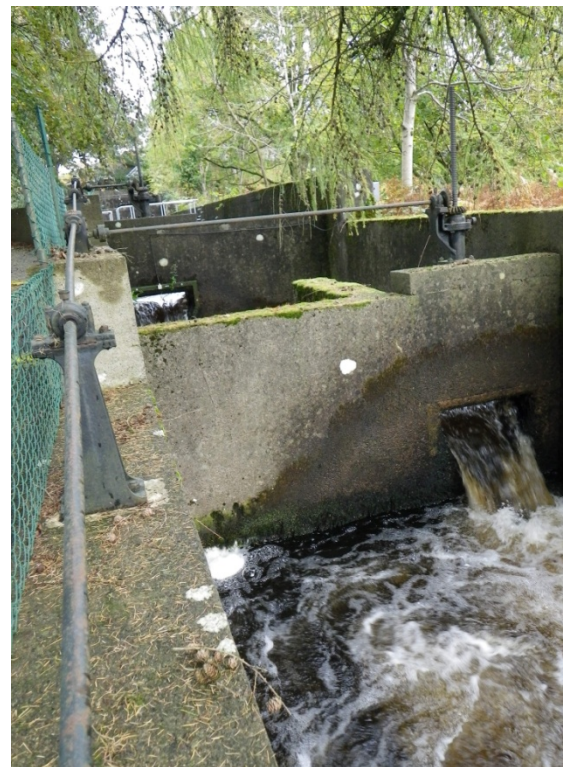
Plate 1b: Original orifices within Sections 6 and 8 – with detector 7 in the background

Debate has ensued over many decades as to the efficiency of Tongland fish pass. In recent years it has been proposed to reduce flows through the pass to facilitate fish passage on an assumption that fish may be impeded by high water velocities or turbulence. However, assessment of the value of such measures requires a baseline impression of movements of fish through the pass. Indeed, any reduction in water flow may seriously impair passage of some sections, for example through the exposed orifices of Sections 6 and 8.

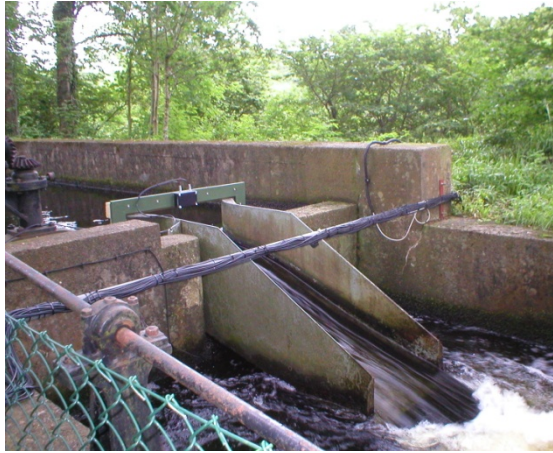
Plate 1c: Section 4 with PIT detector 5 positioned above the resistivity fish counter flume (removed by the 2008 tagging period)

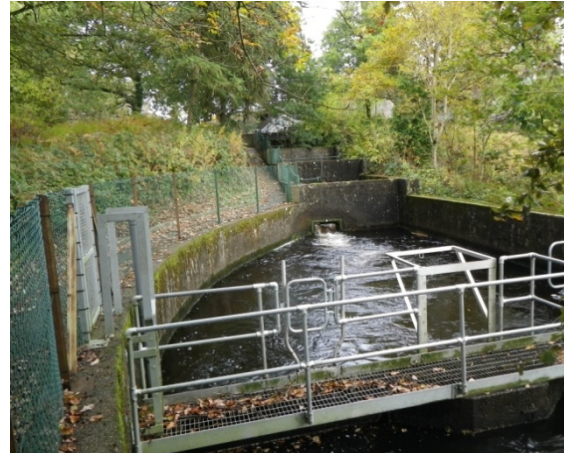
Plate 1d: Resting pool 3 showing central weir with submerged orifice and Vaki fish counter with PIT detector 8 in the background

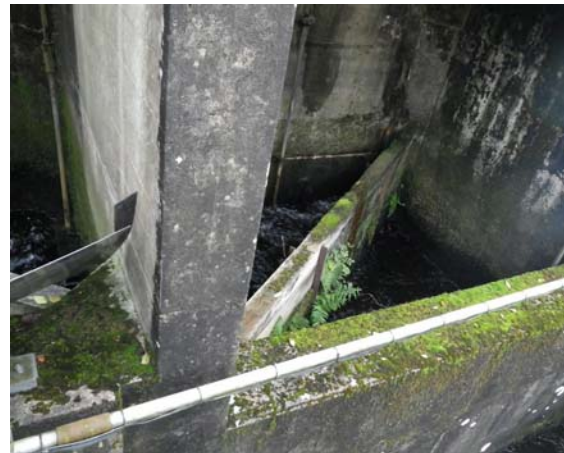
Plate 1f: Section 10 showing diagonal wooden cross walls – all three exits in the dam wall are located within this section

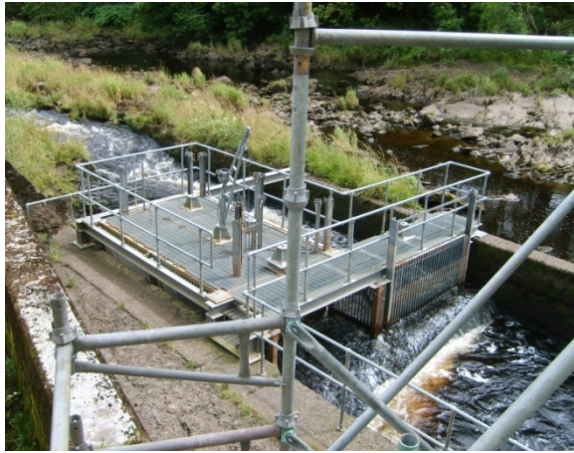
Plate 2a: The fish trap adjacent to Tongland Power Station

Investigations into movements of salmon through the Tongland fish pass were conducted during 2007 and 2008. A box trap (3m x 2.5m x 2.2m high) was constructed and installed adjacent to Tongland power station, approximately 0.9km below the fish pass entrance. The trap comprised a box of metal bars with an in-scale that directed fish in and then obstructed their exit to some degree (Plate 2a). Captured fish were removed by hand-net. The trap was sited in a tidal section of the river and could be by-passed by fish migrating upstream at high water levels. It was therefore expected not to have seriously impeded the run of salmon and to have captured only an unknown proportion of the total population. The trap was fished at low tide, once daily during July, August and November 2007 and July 2008 except during high river levels caused by the dam spilling. Captured fish were anaesthetised, measured and each tagged with a passive integrated transponder (PIT tag) (42-47mm length, 14-15mm width) inserted into the stomach (Plate 2b). The tags were modelled on dimensions of gastric acoustic tags, which are used routinely to track returning salmon and generally remain lodged in the gut (e.g. Stewart et al., 2009). Each tag contained a standard miniature PIT (23mm length 2007, 32mm length 2008).

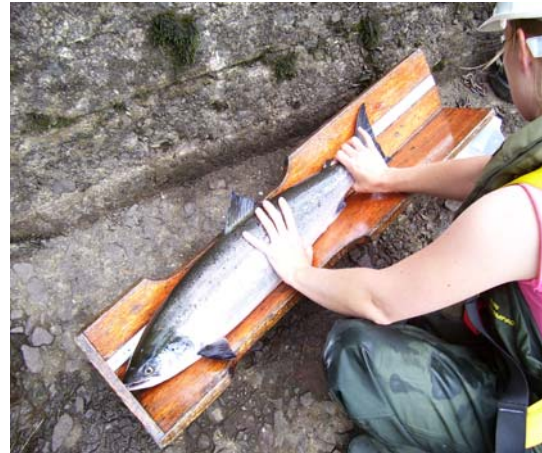
Plate 2b: A trapped salmon being measured prior to tagging

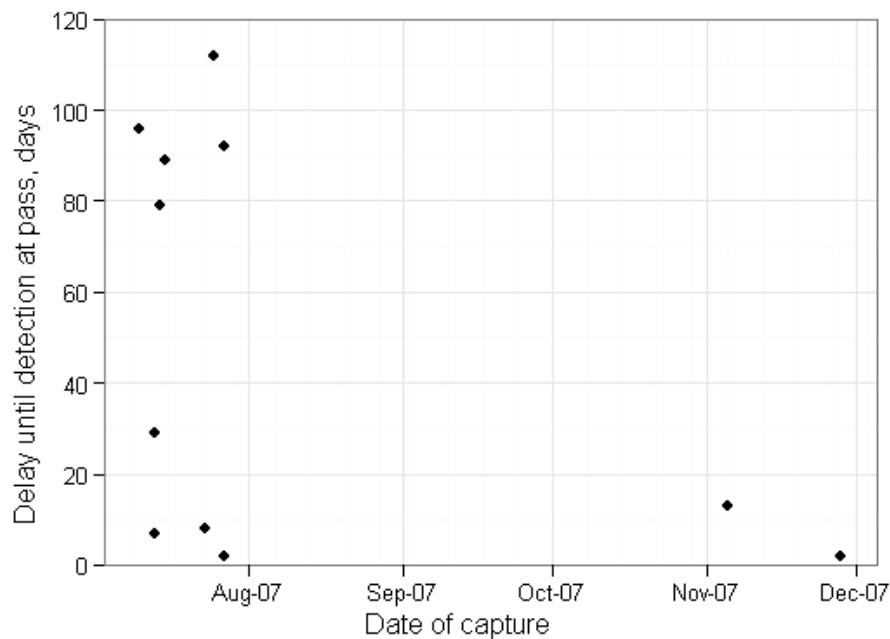
Figure 2: Delay time between release of tagged fish at the box trap and first recorded entry into Tongland fish pass.

There is some evidence that fish tagged in July and August tended either to move to the pass within two weeks or not until autumn (Fig. 2). The two fish tagged in November moved to the pass within two weeks (Fig. 2).

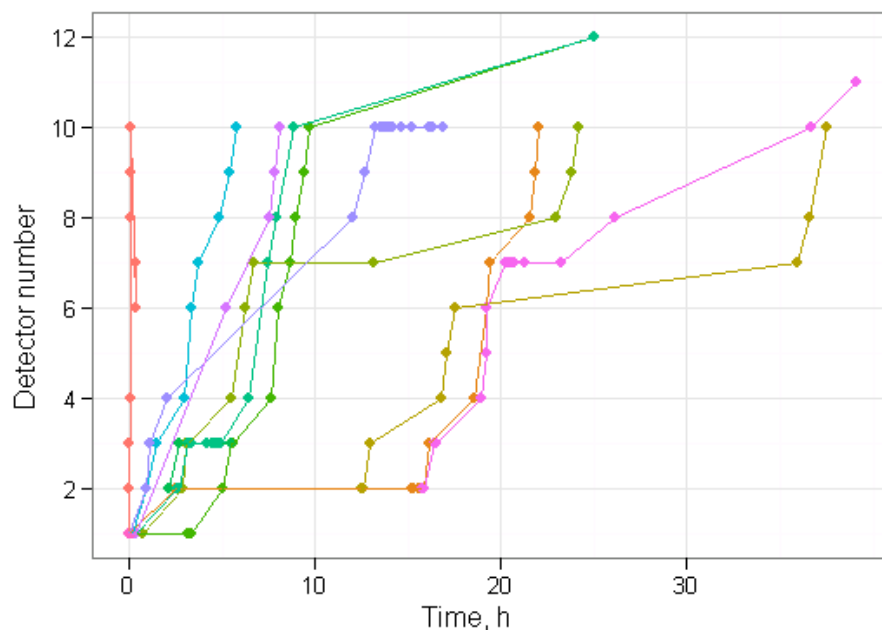
Figure 3: Tracks of fish moving through Tongland fish pass. For clarity of presentation, data for one fish are truncated since it remained between detectors 10 and 12 in excess of 6 days.

A summary of the passage of each fish through the pass is provided in Figure 3. These data were analysed to test for variation in the times taken to traverse the different sections and also the effect of time of year (Figs. 4 and 5). A mixed model was used with fish as a random factor and day of entry and pool as fixed effects. Likelihood ratio tests examined the significance of day of entry to the pass and section on passage rate. Both these factors were significant: section, LR = 25.32, df = 8,  $p = 0.001$ ; day of entry, LR = 4.08, df = 1,  $p = 0.044$ . Inspection of the data reveals generally rapid passage of fish through the pass, with relatively longer periods of time in the longer sections (1 and 3) and in the section 7 resting pool. However, the main variation is due to very long time periods before leaving the pass (section 10).

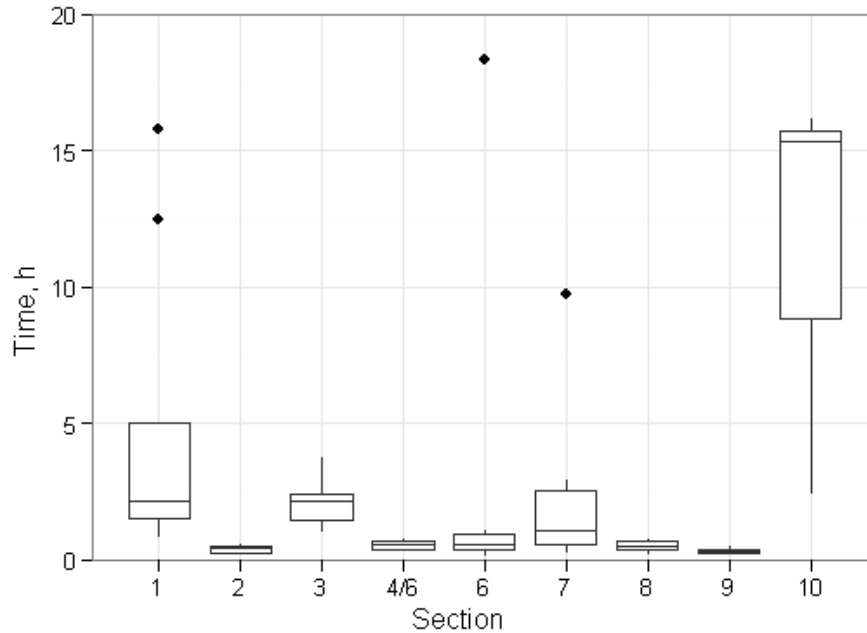
Figure 4: Variation in the time taken by salmon to traverse sections of the Tongland fish pass in relation to section of the pass (see Fig. 2). Boxes indicate median and quartiles, whiskers indicate 95% limits and points indicate outliers. A single large outlier that spent more than 6 days in the upper pass before recorded exit was removed prior to analysis.

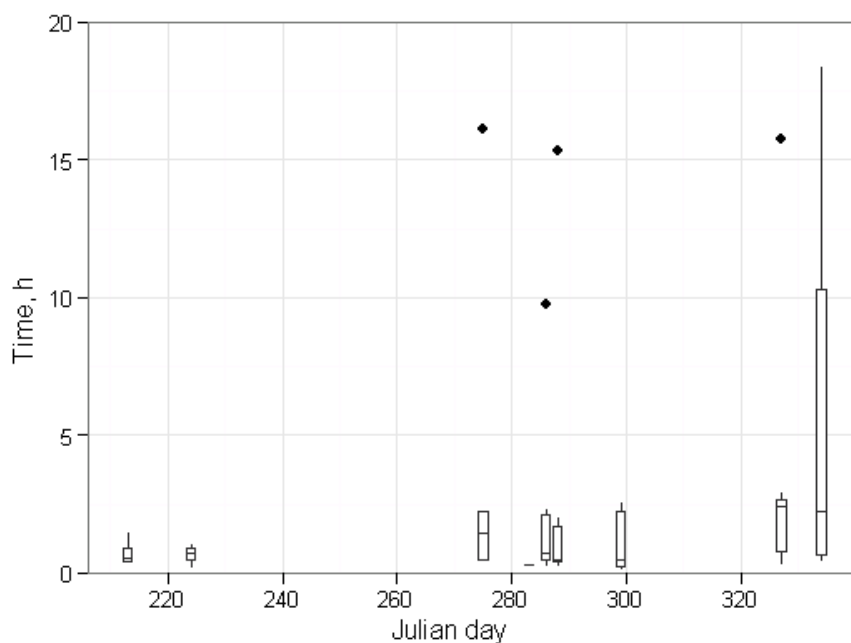
Figure 5: Variation in the time taken by salmon to traverse sections of the Tongland fish pass in relation to day of year they first commenced ascent of pass. Boxes indicate median and quartiles, whiskers indicate 95% limits and points indicate outliers. A single large outlier that spent over 6 days in the upper pass before recorded exit was removed prior to analysis.
